**Risk Assessment Behind Stage and Side Step**

| Business Name: | | Risk Assessor: | | Image: |
|---|--|---|---|--|
| Minchinhampton Market House | | Name | Neil James | |

| Location of Hazard / Area / Process / Equipment: | Activities/storage behind the stage. |

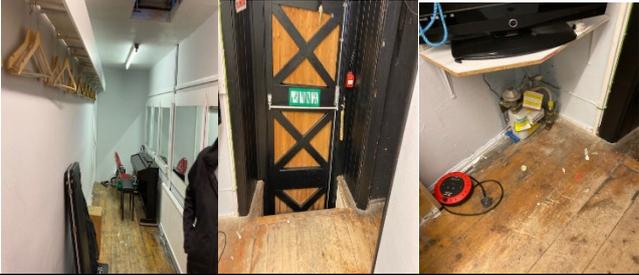
| Activities: | How Harm Could Occur: | People Who Could be Harmed: | |
|---|---|---|---|
| Storage area for electric piano, access ladder to ceiling, storage and Fire Escape to one side. | <ul style="list-style-type: none"> <li>• Trip hazard electric cable on floor.</li> <li>• Potential for ladder to fall from height if not correctly secured or safely accessed.</li> <li>• Potential for damage/rupture to gas meter if struck by significant object.</li> <li>• Potential – spillage /trip hazard.</li> <li>• Steep steps to fire exit – trip hazard.</li> <li>• Fall from ceiling ladder.</li> </ul> | Employees | <input checked="" type="checkbox"/> |
| Paints and cleaning materials left in room. | | Public / Customers | <input checked="" type="checkbox"/> |

| Control Measures Required |
|---|
| <ul style="list-style-type: none"> <li>• Consider adding a small handrail to right hand side of steps leading to the fire exit to assist in fire evacuation.</li> <li>• Consider a safe system of work for initially gaining access and retrieval to unlock the ladder in the ceiling.</li> <li>• Afford a level of reasonable housing protection to the gas main sited on the floor to prevent significant injury to site or person(s).</li> <li>• Ensure tins of paint and other tins are re-sited to a secure storage facility i.e. lockable cupboard.</li> <li>• All appropriate persons receive instruction on use of ceiling ladder.</li> </ul> |
